**BLACKSTONE RIVER BASIN
WORCESTER, MASSACHUSETTS**

**PATCH RESERVOIR DAM
MA 00122**

**PHASE I INSPECTION REPORT
NATIONAL DAM INSPECTION PROGRAM**

AUGUST, 1978

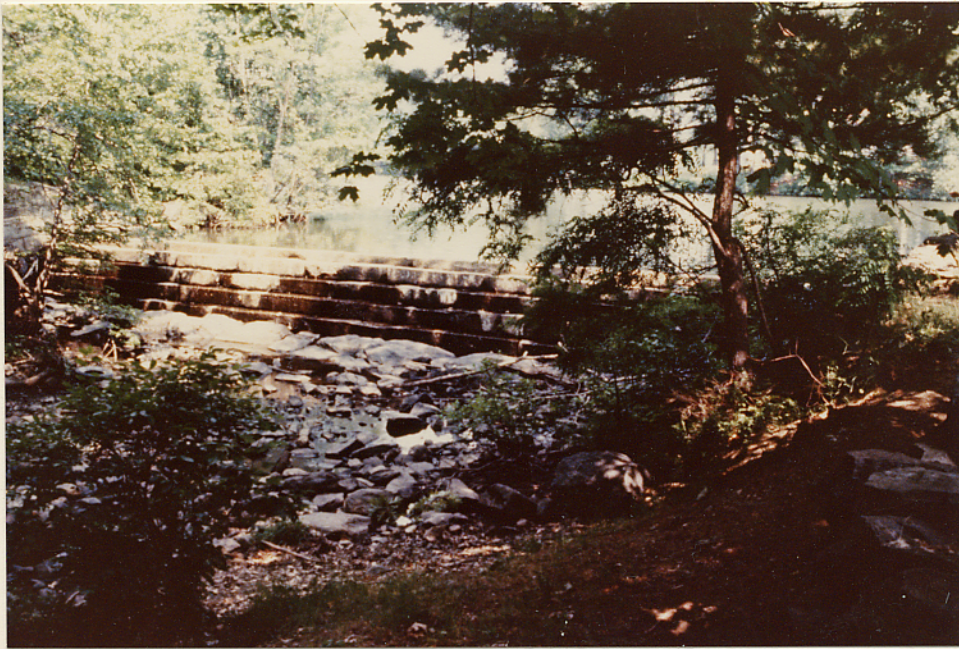
SPILLWAY WEIR, DOWNSTREAM VIEW

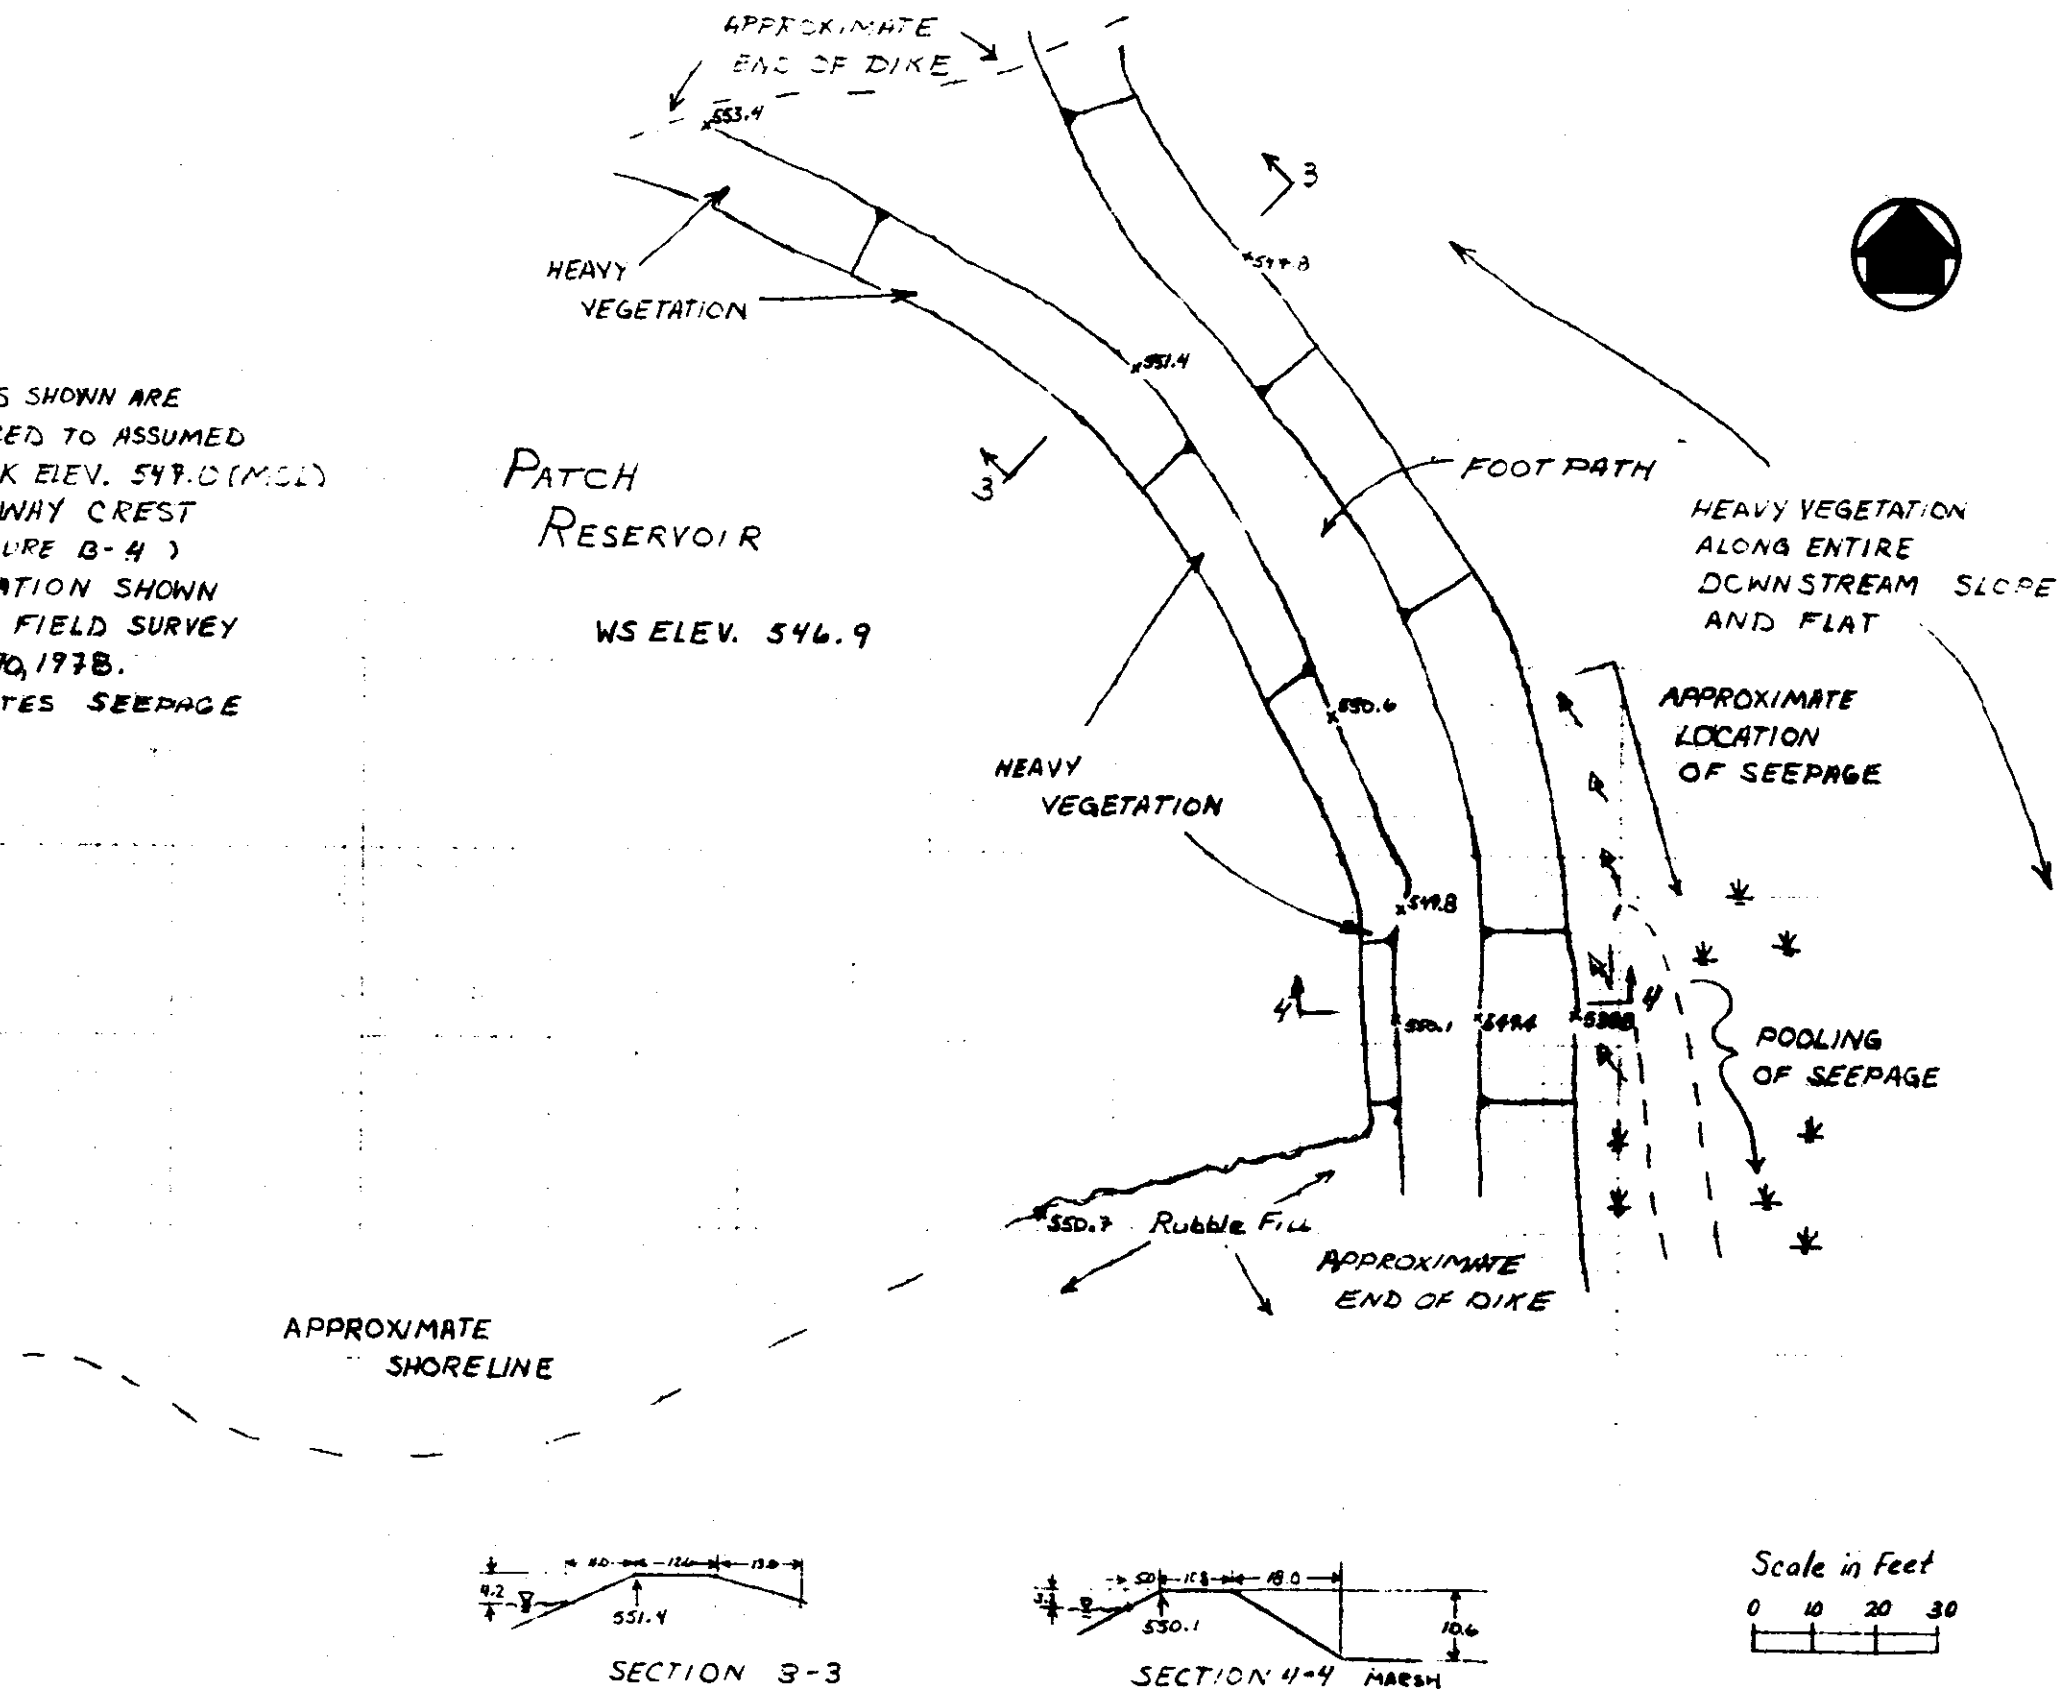
FIGURE B-3. DIKE PLAN AND SECTIONS

The earth dike, located about 800 feet from the spillway, is overgrown with trees on both the upstream and downstream sides, and a footpath runs along the crest. There is no visible slope protection. Seepage was observed along about one-third of the length of the dike, which results in a soft swampy area at the downstream toe. A few animal burrows were noted.

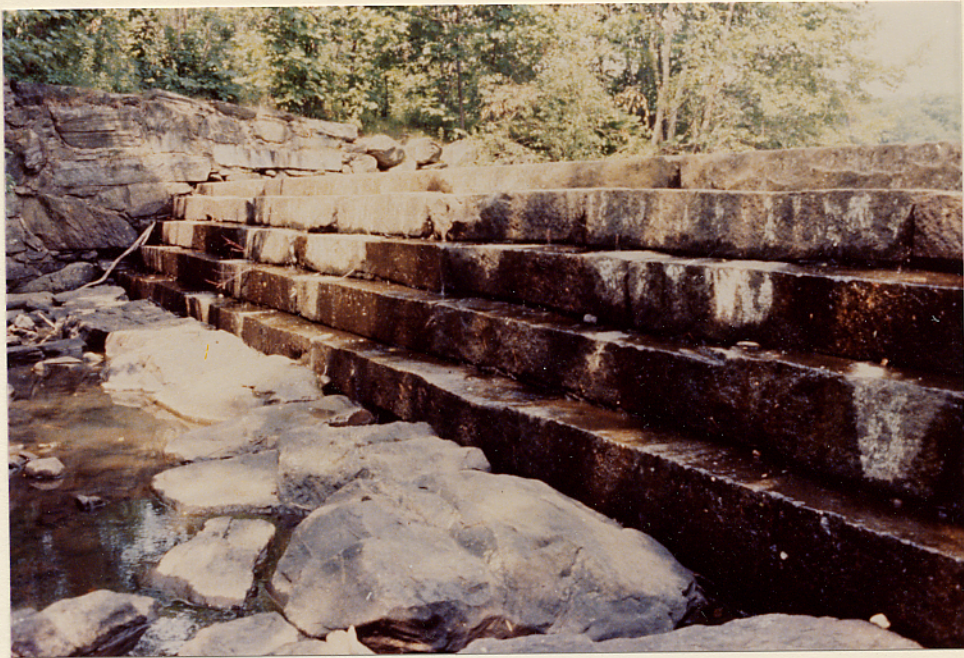
- b. Dam. The impoundment structures consist of a spillway and dike section. The spillway is a stepped stone structure. Granite blocks comprising the crest and cascade are in good condition, although slightly misaligned horizontally. There is a small (6-inch) gap in the crest near the east end of the spillway which is the result of a broken corner on a crest block. Although the pond level was slightly below the crest, water was observed flowing through the gap and also leaking from beneath the first two steps of the cascade. Slight seepage was also observed in the wall at the west abutment, just above the level of the downstream streambed.

The shear pins that secure the second row of blocks appear to have been 1-inch diameter, but have been corroded to about 3/4 inch diameter. Continued deterioration of the shear pins could eventually affect the stability of the weir blocks.

NO. 1 SPILLWAY WEIR

- (5) repair the break in the spillway crest block and seal against leakage through the cascade,
- (6) clear accumulated debris in the spillway channel,

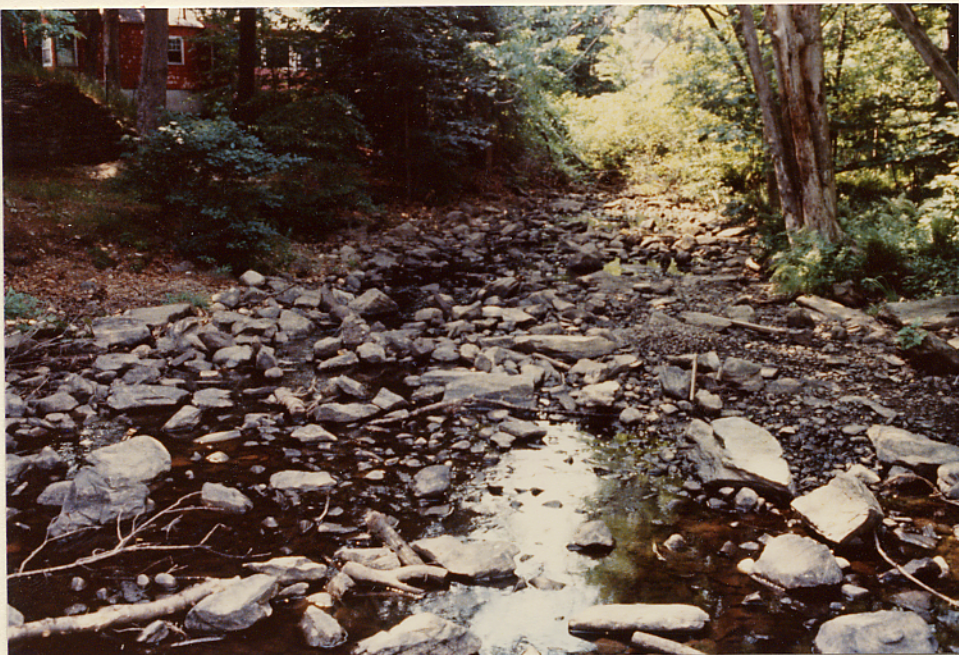
The toe of the spillway is paved with irregular fieldstone blocks. Erosion beneath the stones at the toe has caused some settlement. The downstream earth channel is fairly narrow, winding, and stony, and has minor amounts of debris such as tree branches in it.

- e. Downstream Channel. Water flows into the discharge channel below the spillway for about 1,200 feet before entering Patch Pond. Houses are located along the east side of the spillway channel for at least 500 feet downstream. A storm drainage system for residential development enters the channel through a culvert about 400 feet downstream of the spillway. Frequent flooding is reported by the residents. The stream is eroding its banks in several places which causes trees to fall into the channel. The channel generally contains brushes and miscellaneous debris as well.

NO. 2 CHANNEL DOWNSTREAM OF SPILLWAY

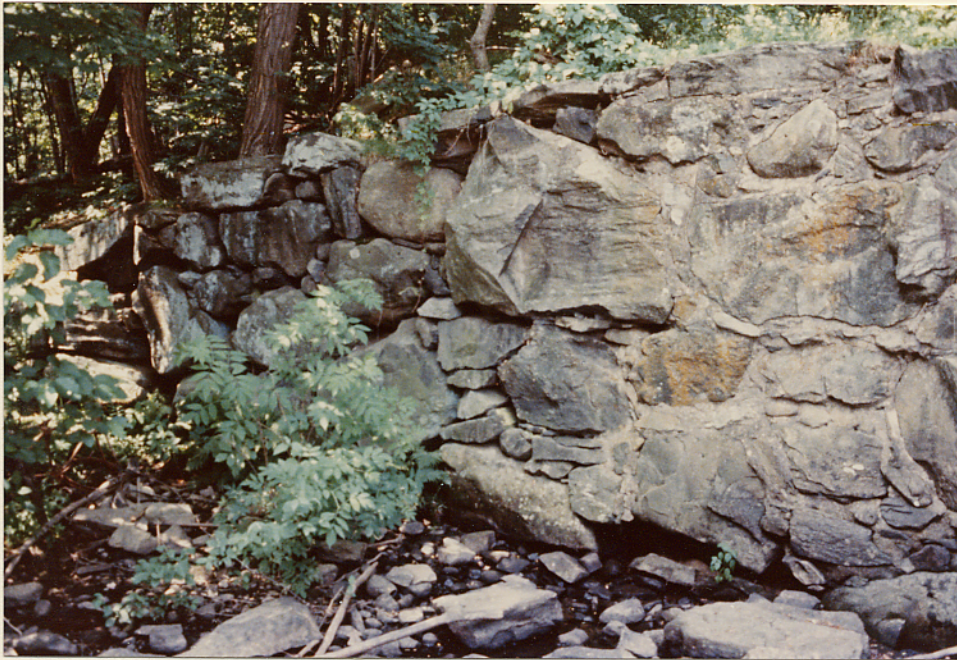
The training walls at each end of the spillway are mortared fieldstone in generally good condition, although the mortar is missing from the lower stones on the upstream end of the west wall. The walls abut natural ground and are practically overgrown by bushes and trees on the downstream side. There has apparently been some tree cutting on the upstream side of the left abutment.

NO. 3 DETAIL OF WEST SIDEWALL OF SPILLWAY

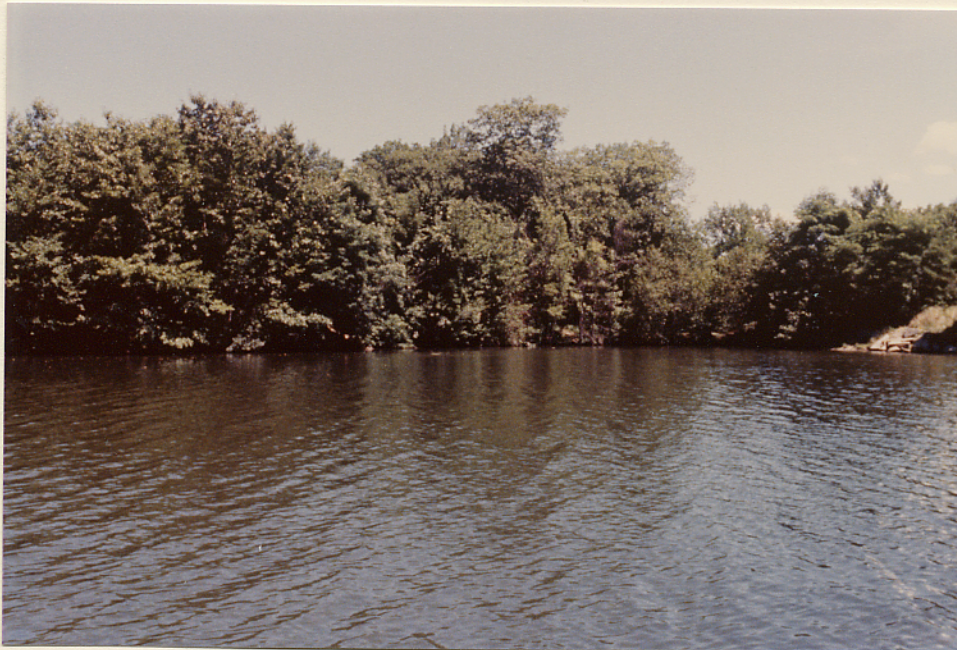
NO. 4 DIKE SECTION — FIGURE B-3

It is recommended that the Owner immediately investigate the seepage at the toe of the dike, clear all debris from the spillway, remove all trees from the dike, and install a gated low-level outlet. Also, erosion of the upstream face should be repaired and riprap added to prevent continued deterioration of the dike. It is recommended that the Owner employ a qualified consultant to evaluate the stability of the dike and the seepage at the downstream toe of the dike. Further, a more detailed investigation should be made of the hydraulic and hydrologic aspects of the site.
